March 15, 2024

RE: *Pointe Towers Condominium, Inc.*  
*555 Gulf Way*  
*St. Pete Beach, Florida 33706*  
*KEG File #22RP-1034: Milestone Inspection*

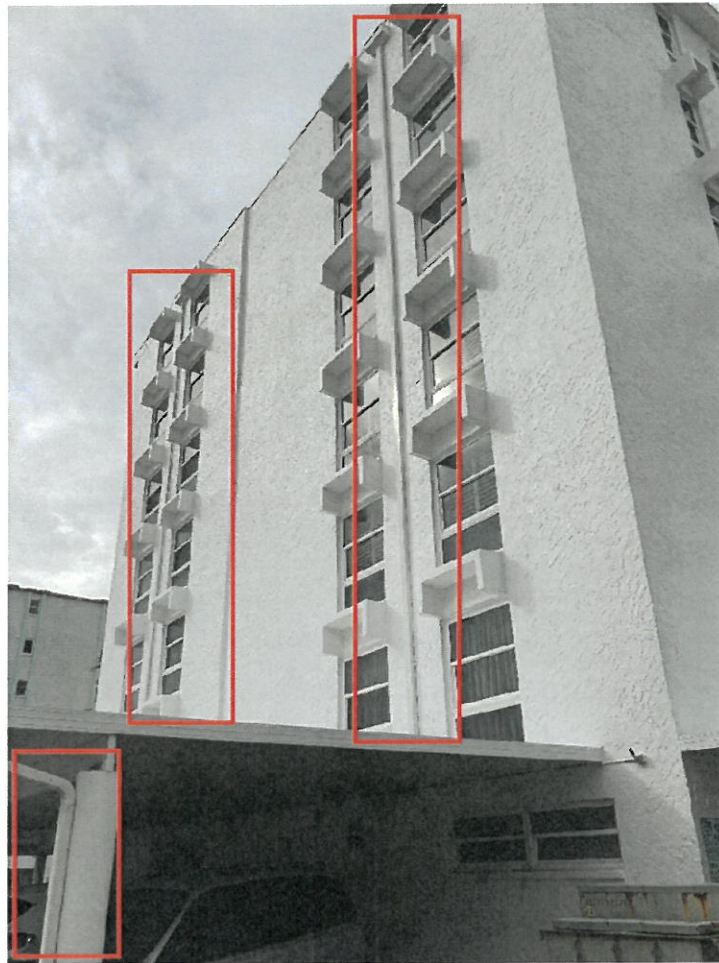
As noted above, undermining and loss of containment soil can occur due to excavation in the vicinity or washout caused by stormwater runoff. High velocity runoff and improperly sloped adjacent grade can cause soil loss surrounding the footings and reduce the capacity of the underlaying soils which increases the possibility of foundation movement. Visibility of the soils was limited to the west face of the building, as the other faces of the building had asphalt covered ground surface. The drainage control methods, such as gutters, outflow onto the carport roof or the asphalt parking area. KEG did not note any significant depressions or other indications of soil loss in the parking area.

Downspout Outflow with No Soil Loss or Indication of Significant Soil Loss

At this time, KEG does not believe that additional investigation into the site soils is necessary.

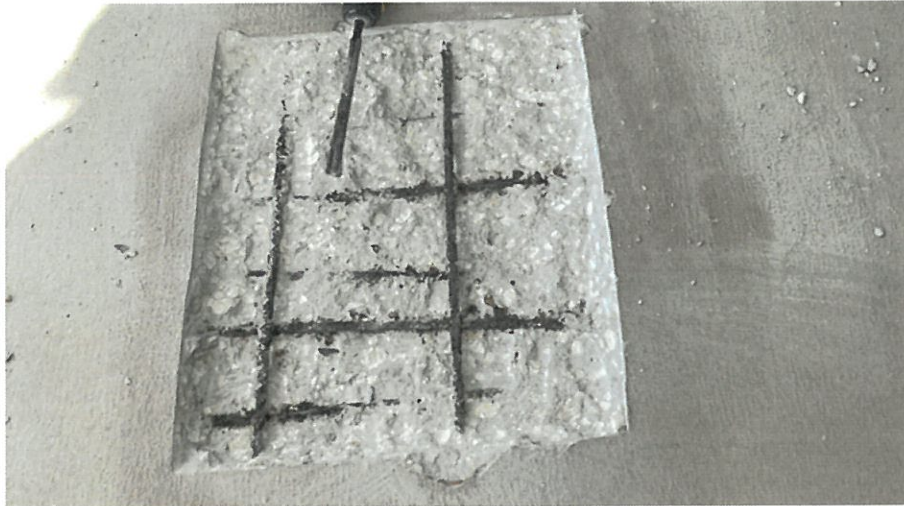
Repair In-Progress of Identified Spall on Unit 2N Balcony (Taken 2023-02-14, Repair Completed)

Repairs were performed during the building envelope project, which had been completed in September of 2023, where KEG was the EOR during the project. The observed repairs appeared to be in generally excellent condition and KEG did not identify any additional cracking or spalling during the inspections.

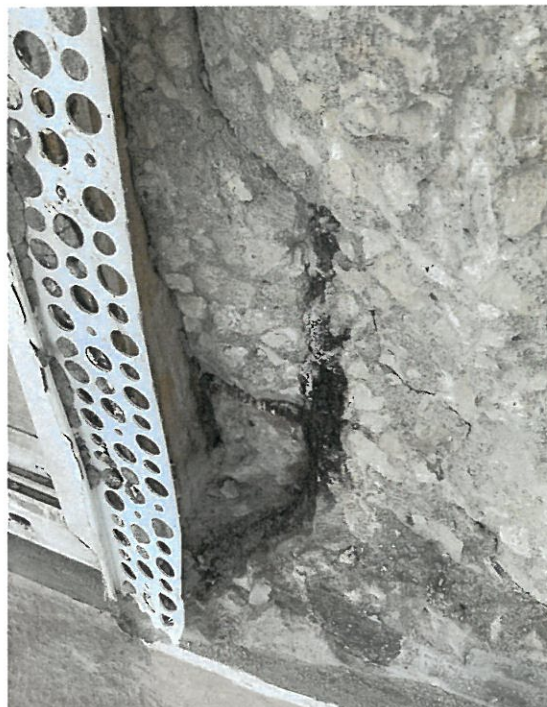
Repair In-Progress of Identified Spall on Unit 4N Column (Taken 2023-02-14, Repair Completed)

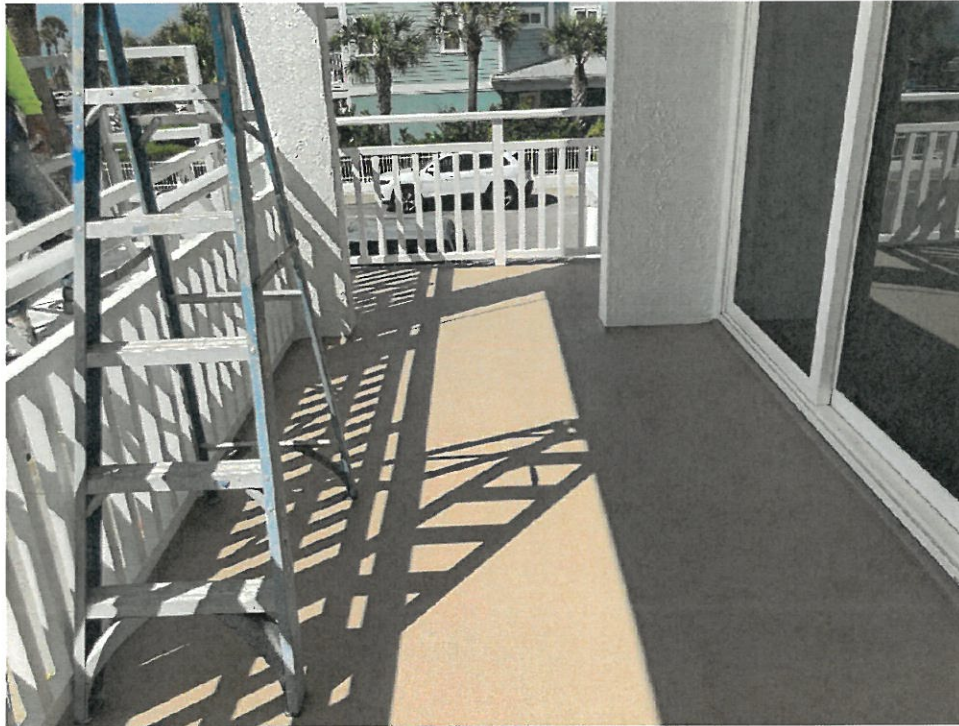
Balcony 2N after Repair Completion (Taken 2023-03-27)

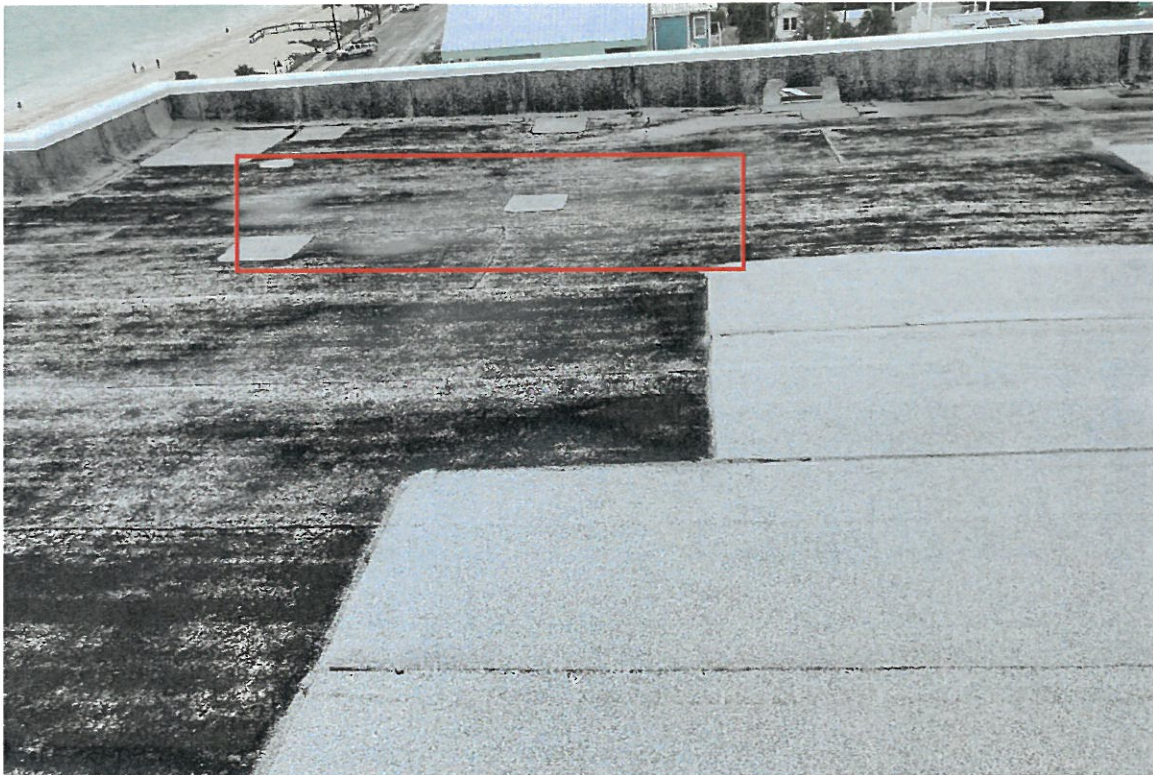
Existing Condition of Roof System with Ponding Location Identified

Based on the observed condition of the roof, the current design appears to be performing moderately well as KEG noted several areas it appears that water ponded in enough quantities that deeper sections may not dry within a 48-hour time period. It appears to be primarily the result of the design of the roof, the drainage system and likely age of the overall system. KEG observed numerous locations where small low areas had developed in the roof system and were holding stormwater. These areas varied in size but were scattered across the roof.

KEG did not observe any areas where there were signs of overloading or significant deterioration of roof structural elements. However, given the current condition of the roof weatherproofing systems, KEG recommends regular inspections by a roof specialist to ensure proper performance and develop a proper timeline for replacement.

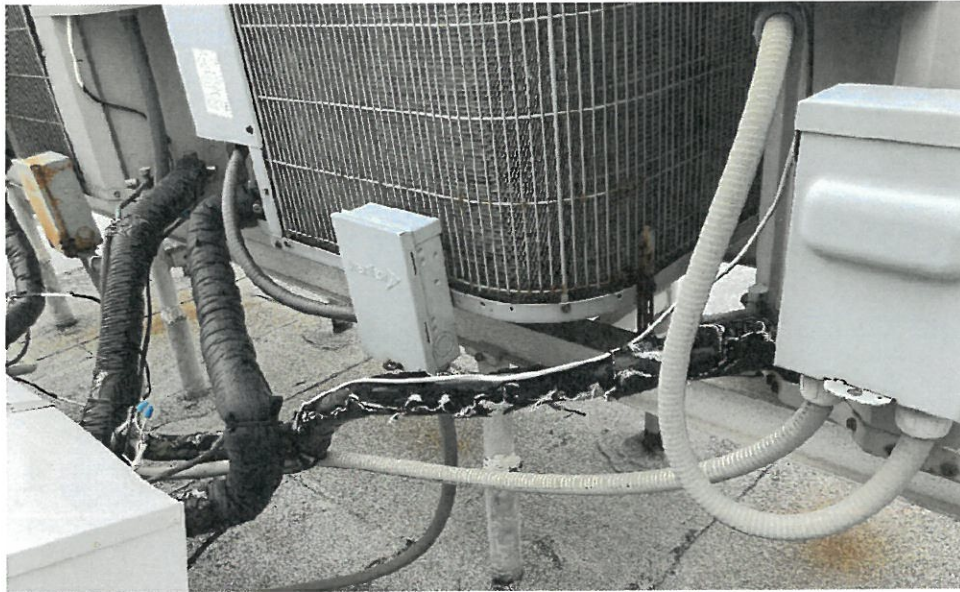
The condensers for the unit air conditioning equipment had all been installed on metal stands that raised the condensers above the roof to allow for maintenance of the roof under the mechanical systems. The HVAC equipment stands were observed to be in good condition and there appeared to be minor oxidation of the fasteners and straps that secured the equipment to the stands. Over time, the oxidation may become an issue that will affect performance, but there were not any specific concerns at the time of the inspection.

Oxidized Fasteners on Roof Level

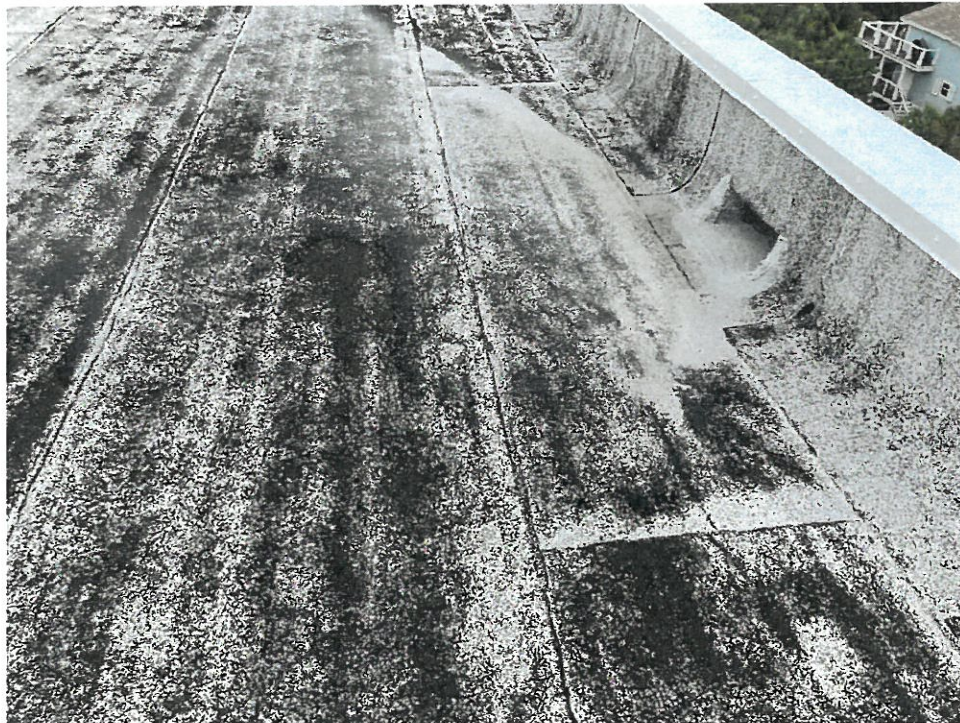
Primary drainage of water on the roof occurs from the roof slope towards the perimeter parapet scuppers. The scuppers appeared to be performing their task adequately, but there were a number of areas where ponding moisture was observed on the roof system. These areas appeared to be deep enough that the moisture would remain after a 48-hour drying period, which increases the likelihood of damage to the roof and moisture penetration under the weatherproofing system.

Scupper with Minor Ponding (Scupper Appears to be Above the Sloped Roof)

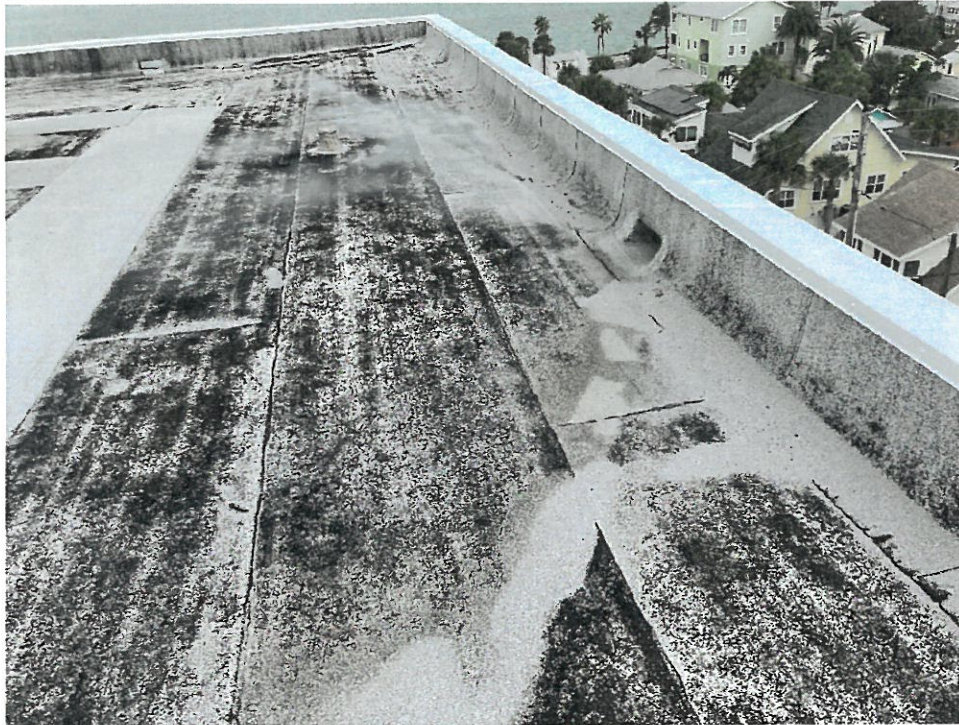
KEG also noted large amounts of protective granules from the modified bitumen sheets had been washed away, as well as what appeared to be repairs performed to the roof system. When the granules are washed away or dislodged due to abrasion from weather or traffic, they expose the asphalt impregnated fabric to UV radiation, which is the primary factor in the breakdown and damaging of asphaltic materials. As these sheets are exposed to UV radiation, they lose their flexibility and begin to crack. These cracks begin to grow in size and depth as the sheets are subjected to more movement from traffic, loading and sunlight until the cracks damage the ability of the modified bitumen sheet to prevent moisture intrusion, causing leaks. It is likely that the repaired areas were, at least in part, the result of the exposure and damage that occurs as a result of granule loss.

Granule Loss and Ponding on Roof Membrane Surface

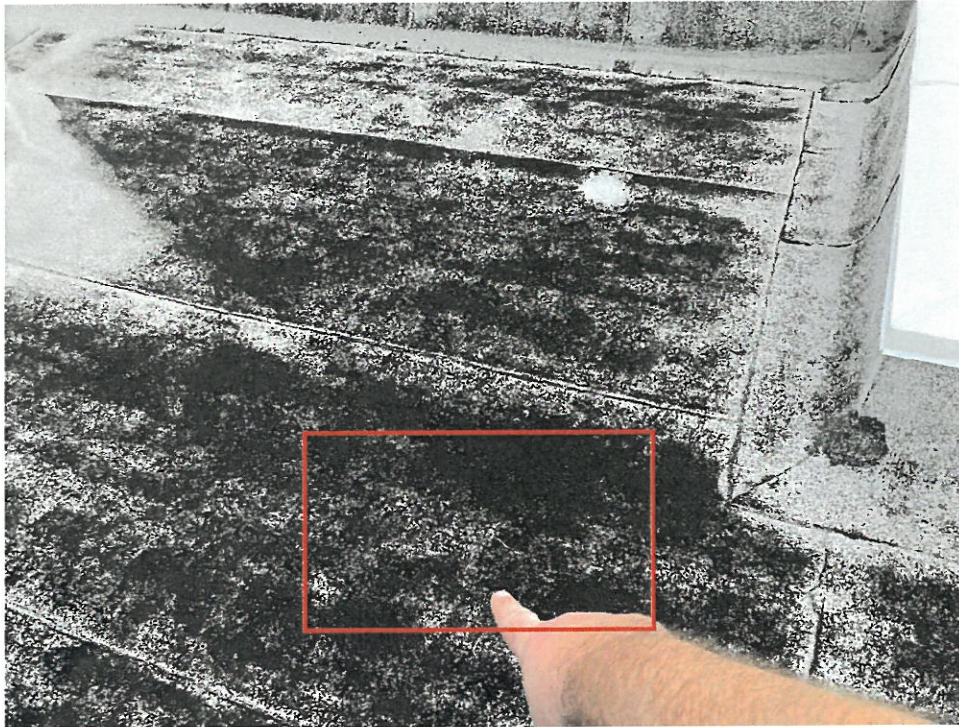
KEG noted one area that appeared to be developing signs of moisture intrusion. The area was an apparent bubble under the modified bitumen sheets that was identified when it was stepped on. No visible signs of cracking or failure of the sheets in that area were observed. This indicates that any moisture may be entering the system through another location, such as the adjacent parapet or overlapping seam. Outside of that location, the roof appeared to be well adhered to the substrate.

Noted Soft Spot/Bubble on Roof System

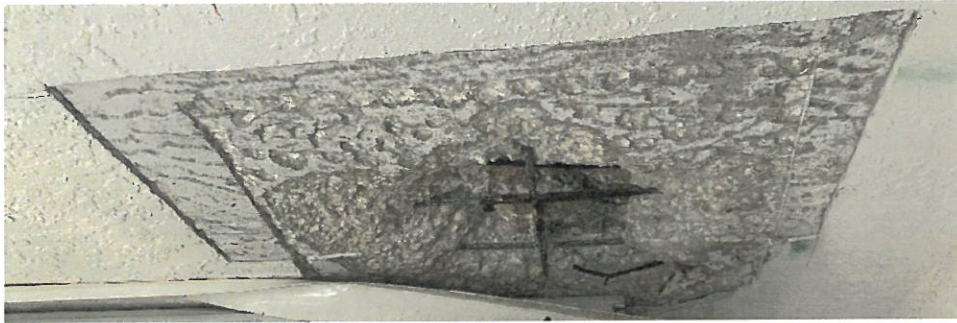
Repair In-Progress of Identified Spall on Underside of Balcony Slab in Unit 3N (Taken 2023-02-14, Repair Completed)

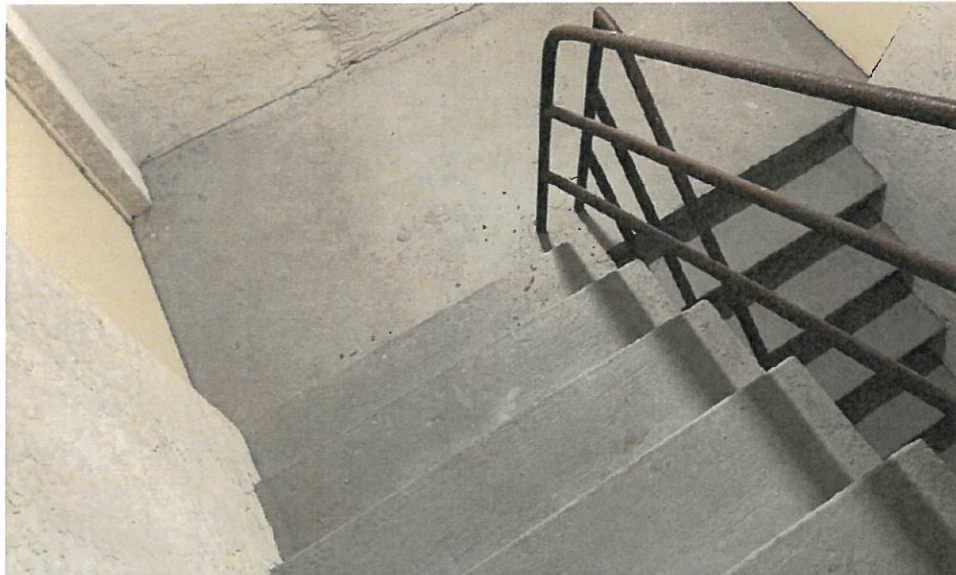
KEG also documented the state of the handrails for the stairwells. The handrails were constructed of steel and coated with a paint covering to limit oxidation. KEG did not observe regularly spaced vertical members and they were not installed on both sides of the stairwell. The railings were not continuous and did not have the code required 12 inch extension beyond the top and bottom steps. It is important to note that structures and elements that were up to code at initial installation have been grandfathered in, but significant repairs to any system will require updating the given element to new code requirements. KEG recommends the Association should review with their legal counsel on the outdated guardrail and handrail systems at the stairs.

Noncontinuous and Single-side Installation of Railings for Exit Stairwell

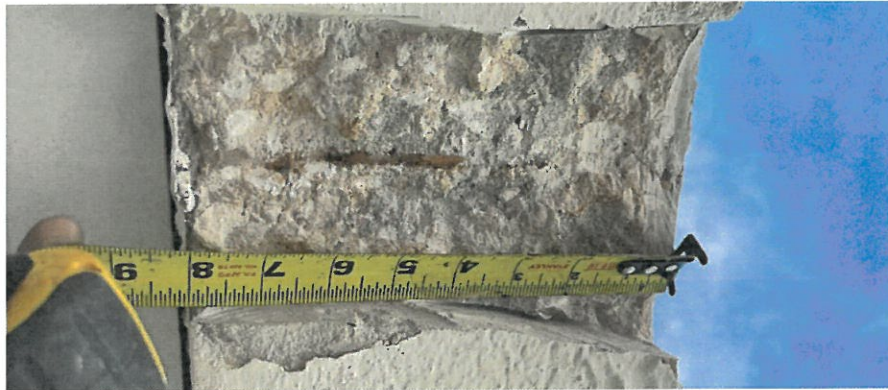
In-Progress Repairs from Completed Building Envelope Project (Taken 2023-02-10, Repair Completed)

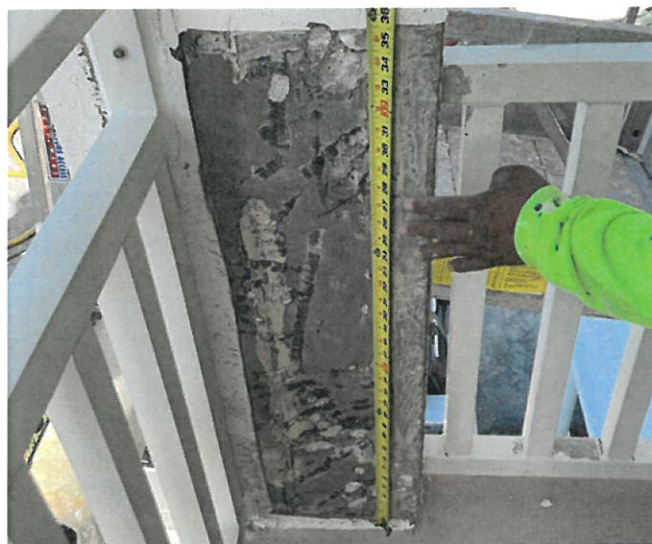
ICCP Protected Column with Repairs Limited to Debonding Stucco Finishes (Taken 2023-02-10, Repair Completed)

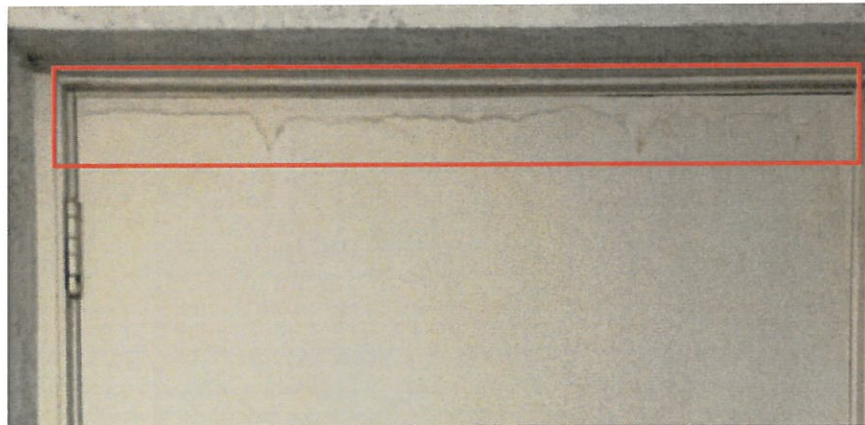
KEG observed a second door that exited into the east stairwell from one of the unit bedrooms. These doors appeared to be wood with wood framing, similar to the main unit entrance. The doors appeared to be in moderate condition but KEG noted what appeared to be moisture staining that may be the result of condensation due to the interaction between interior and exterior air at the edge of the door.

East Stairwell Door for Unit 3N with Apparent Moisture Staining

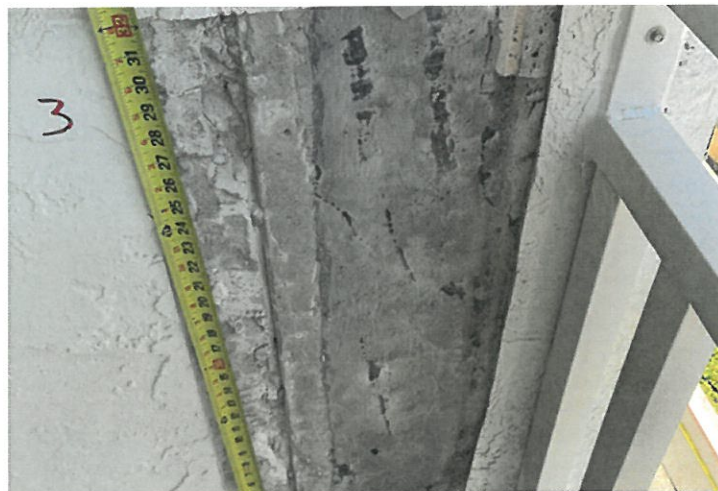
Repair In-Progress of Debonded Stucco (Taken 2023-02-10, Repair Completed)

Hollow sounding stucco accompanied by major cracking and movement of the stucco material can be indicative of two behaviors. The first is that debonding of the stucco finish has progressed to the point of failure and movement away from the building or substrate. This condition leads to falling stucco, which can be a hazard for pedestrians and vehicles parked below the building. With this in mind, the areas of unsound and cracking stucco were repaired during the building envelope project.

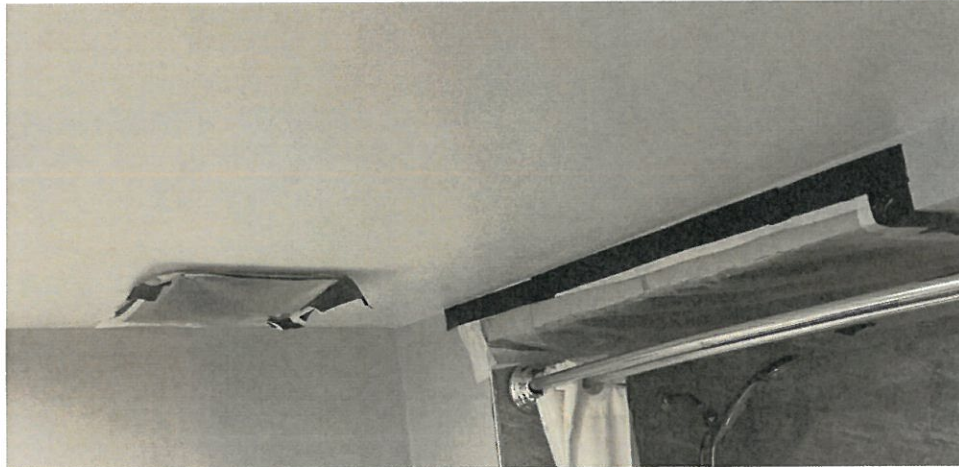
Unit 4S – Bathroom Finishes Damaged due to Leak from Above

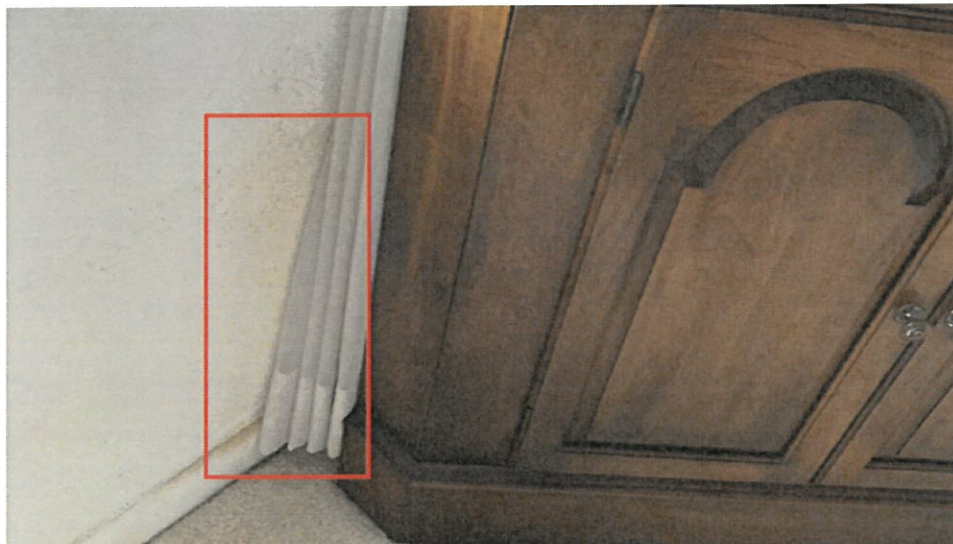
Unit 5N – Apparent Discoloration, Indicative of Moisture Intrusion which appears to be Older

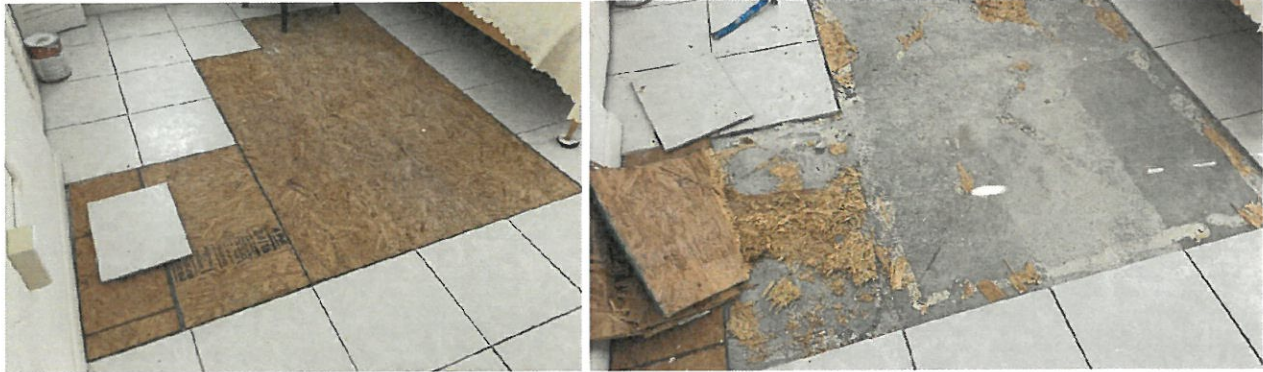
trip hazard. The tile sections were identified through traffic and sounding. In order to limit damage to the existing finishes, the OSB sheathing was removed and the slab appeared to be in good condition with no cracking or apparent unsound material was observed.

Removed Tile Finishes from Unit Bedroom and Exposed Slab

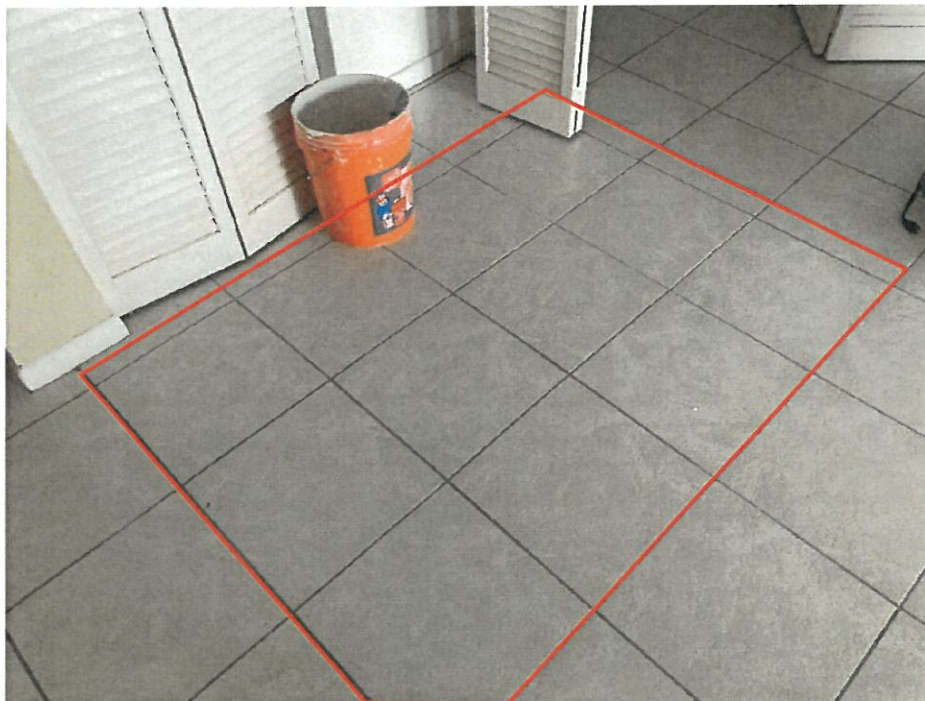
However, KEG did note one unit, Unit 4N, that appeared to have debonded tile finishes. The unit was in the middle of renovation and KEG observed three areas within the unit where tile finishes were unsound or had been removed from the surface of the concrete slab. Two of these areas were in one of the bedrooms of the unit and the third was in the living room between the entrance and the kitchen. The areas in the bedroom were adjacent to each other and one section of it, an area of approximately 20 feet, had been covered with OSB sheathing likely to limit the possibility of a

Section of Apparent Debonding Tile Finishes

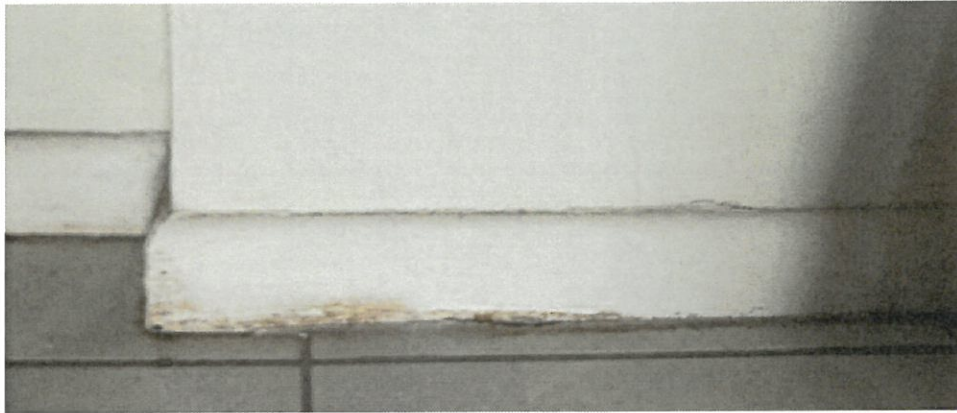
KEG also observed what appeared to be moisture damage at the base board of the small pantry closet adjacent to where the water heater had been installed and the client noted that the unit had previously had overflow problems from the HVAC unit, which has since been replaced. Apparent damage was also observed in the top of the pantry. Based on the observed conditions, it is possible that over time the moisture degraded the grout and the tile debonded from the concrete substrate. KEG recommends that, if the tile is removed for repair that the condition of concrete slab underneath be inspected for any spalling or any other deficiencies.

Evidence of Moisture Exposure in Pantry Closet

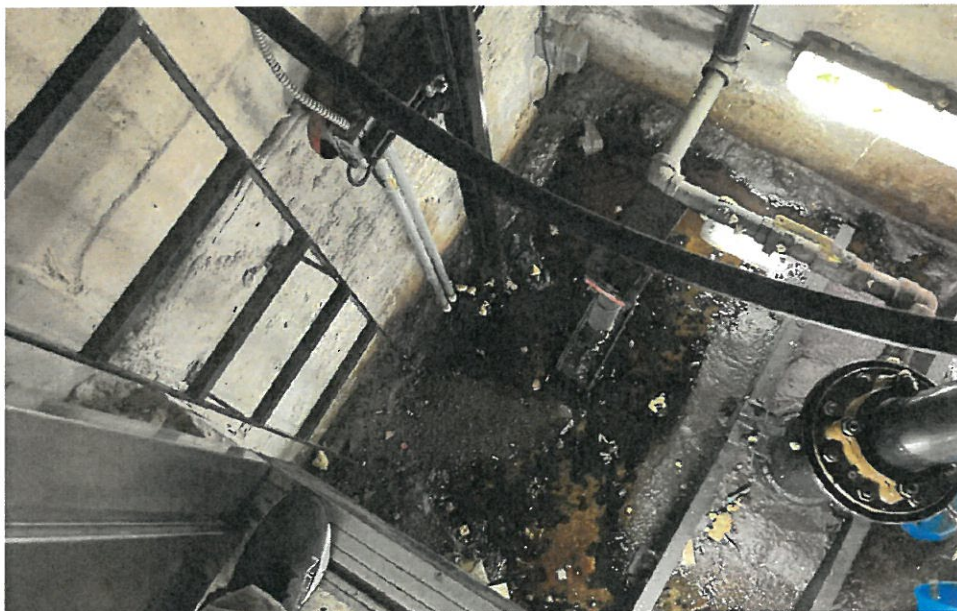
KEG was given access to the elevator pit and documented the current state of both the pit and the shaft. KEG observed that the concrete appeared to be in good condition with no noticeable spalls or significant cracking. The elevator shaft did not appear to be suffering from distress. KEG did not observe any significant oxidation or degradation of the elevator systems. However, KEG noted fluid ponding on the floor of the elevator pit. The fluid appeared to be hydraulic material that may have leaked from the elevator systems. Following notification of the client, the client informed KEG that the elevator maintenance company had been contacted for an inspection. KEG recommends that the association regularly inspect the pit and drain as needed in order to limit the exposure of the reinforcement to excessive moisture. Limiting moisture in the elevator pit will also extend the life of the mechanical systems. KEG did not observe any significant signs of cracking or spalling as a result of moisture intrusion.

Elevator Pit with Ponding Fluid in Bottom
