September 8, 2020

RE: *Pointe Towers Condominium, Inc.*  
*555 Gulf Way*  
*St. Pete Beach, Florida 33607*  
*KEG File #20RP-0462: Additional Services – Owner Plumbing*

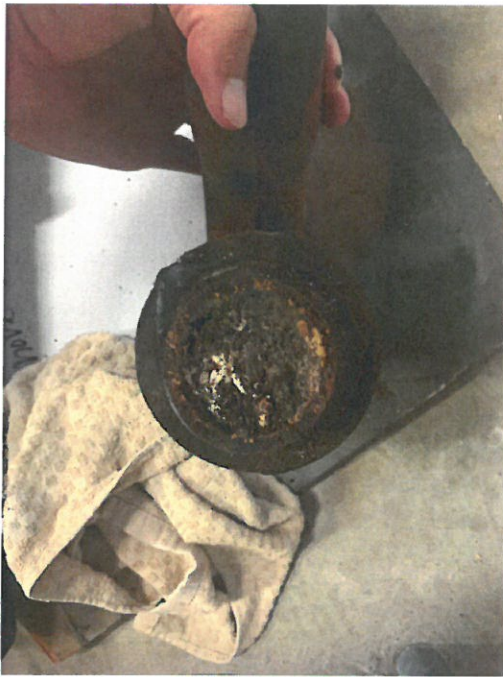
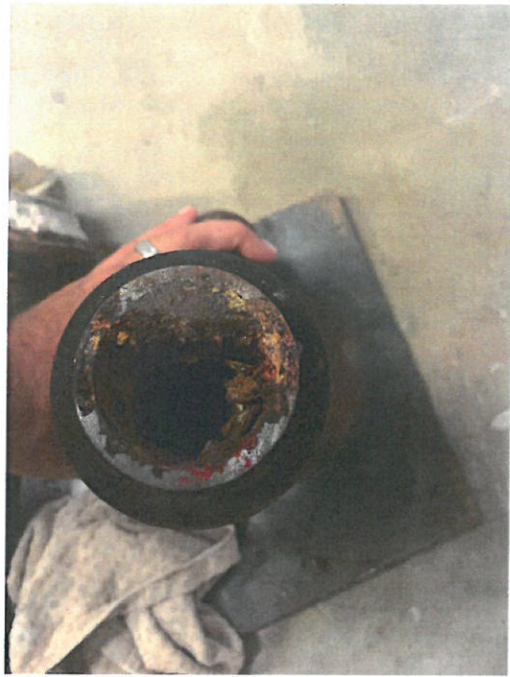
The lateral pipe and p-trap from Unit #4S was removed by plumbers for repair after a major leak had occurred into the units below 4S. KEG observed these failed components during the site visit. The p-trap showed no visible cracking on the exterior, however the interior of the p-trap was completely clogged and debris of the blockage could be seen at the both ends of the pipe. The lateral pipe had a severe crack observable from the exterior of the pipe.

P-Trap Blockage of Unit 4S

As previously stated in the letter to Pointe Towers dated March 3, 2018, KEG's professional opinion is that the piping and horizontals are past their serviceable life. KEG highly recommends for the Owners to replace the lateral pipes and fittings that have extended beyond the useful life as previously recommended to Pointe Towers in 2018. If the pipes are not replaced, KEG recommends that the Owners have an inspection completed for the interiors of the lateral pipes and fittings to access the condition of the pipe. A high probability of failures, such as cracks and bursting pipes are imminent due to age and debris build-up on the interior of the pipe. Similar to the sanitary lines, the portable water lines are nearing the end of the useful life. The maintenance, detection, and replacement of the sanitary and portable pipes are much more cost effective than a catastrophic flood from a burst pipe to the owner and surrounding units.

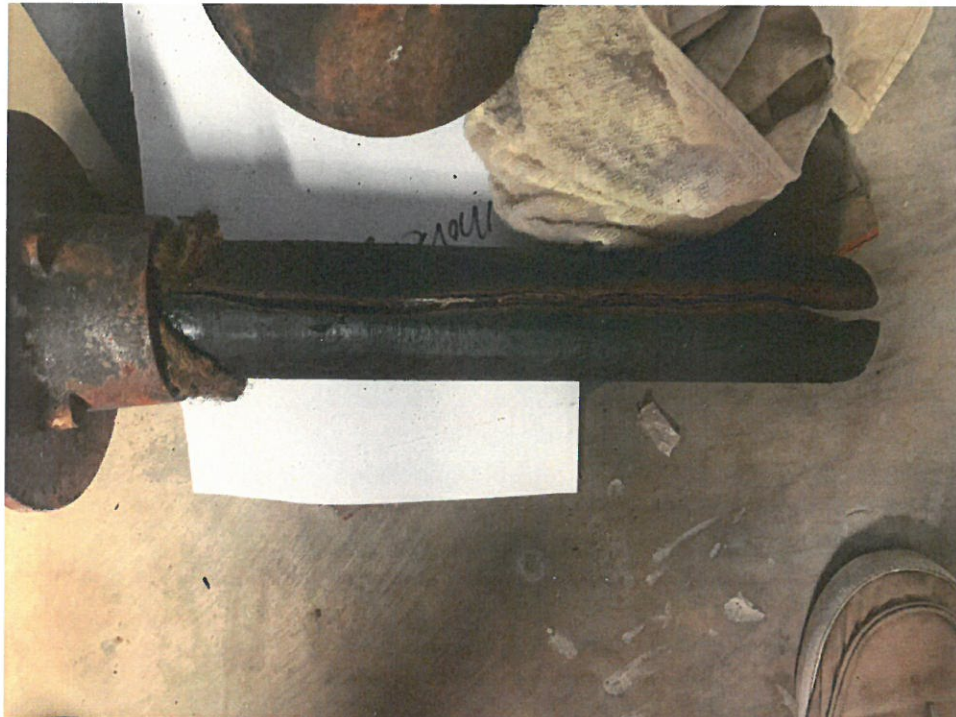
Cracked Pipe from Shower Drain of Unit 4S
