March 13, 2018

*PROJECT: Pointe Towers Condominiums, Inc.  
555 Gulf Way  
St. Pete Beach, FL 33607  
KEG File #17RP-0232: Owner Plumbing*

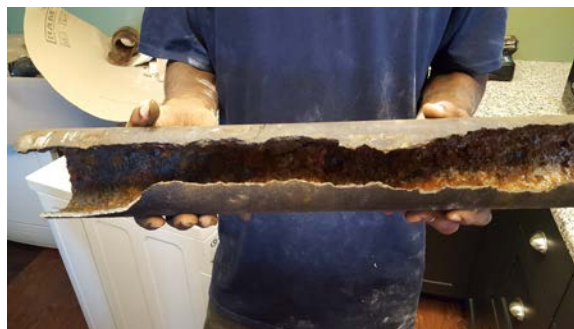
Similar to the vertical stacks for the discharge or sewer lines, the horizontal or lateral lines to the vertical stacks are at the end of the life span. Evidence of this has been seen within unit owners who have remodeled and were required to remove and replace piping. Detergents, grease, chemicals, sands or salts, bodily waste all contribute to the deterioration of the cast iron pipes.

Examples of Cast Iron Piping Replaced at Pointe Towers

KEG's professional opinion is the piping and horizontals are at their end of serviceable life. KEG recommends the Association make each individual unit owner aware of the foreseeable issues and remediation as well as related costs with the unit owned plumbing systems component. Maintenance and detection of these problems systems and component prior to a leaking pipe is much more cost effective than a catastrophic flood from a burst pipe to the owner, and surrounding units.
