Uniform Mitigation Verification Inspection Form

Inspection Date: 5-20-2025			
Owner Information			
Owner Name: Pointe Towers Condo Association			Contact Person: Theresa
Address: 555 Gulf Way			Home Phone:
City: St. Pete Beach	Zip: 33706		Work Phone:
County: Pinellas			Cell Phone:
Insurance Company:			Policy #:
Year of Home: 1970	# of Stories: 7		Email:

Inspectors Initials ER Property Address 555 Gulf Way, St. Pete Beach, FL 33706

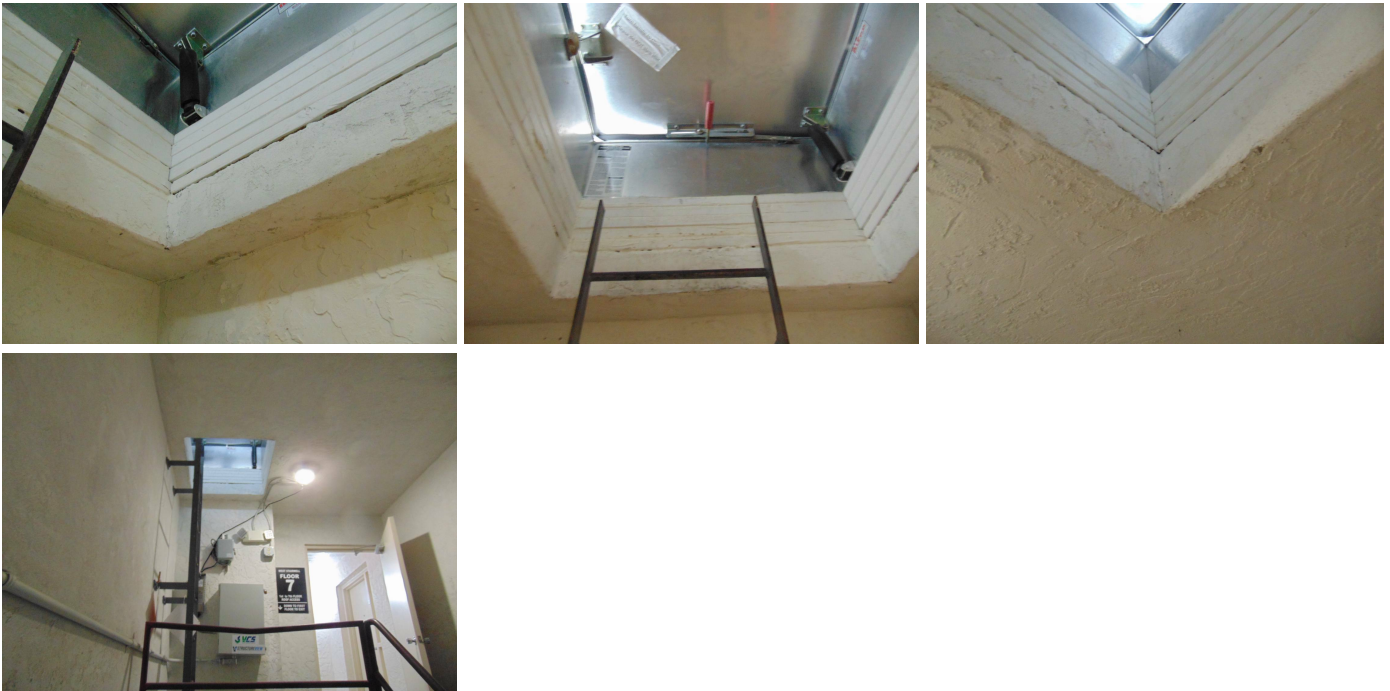
Roof Deck Attachment Photos

- ☒ D. Reinforced Concrete Roof Deck.
- ☐ E. Other:
- ☐ F. Unknown or unidentified.
- ☐ G. No attic access.

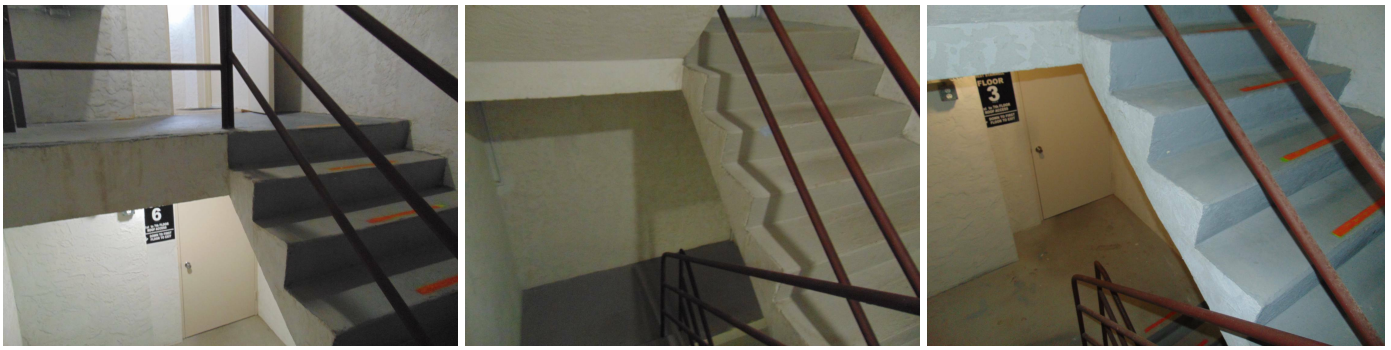
- ☒ A. SWR (also called Sealed Roof Deck) Self-adhering polymer modified-bitumen roofing underlayment applied directly to the sheathing or foam adhesive SWR barrier (not foamed-on insulation) applied as a supplemental means to protect the dwelling from water intrusion in the event of roof covering loss.
- ☐ B. No SWR.
- ☐ C. Unknown or undetermined.

SECONDARY WATER BARRIER (SWR)
