March 15, 2024

RE: *Pointe Towers Condominium, Inc.*  
*555 Gulf Way*  
*St. Pete Beach, Florida 33706*  
*KEG File #22RP-1034: Milestone Inspection*

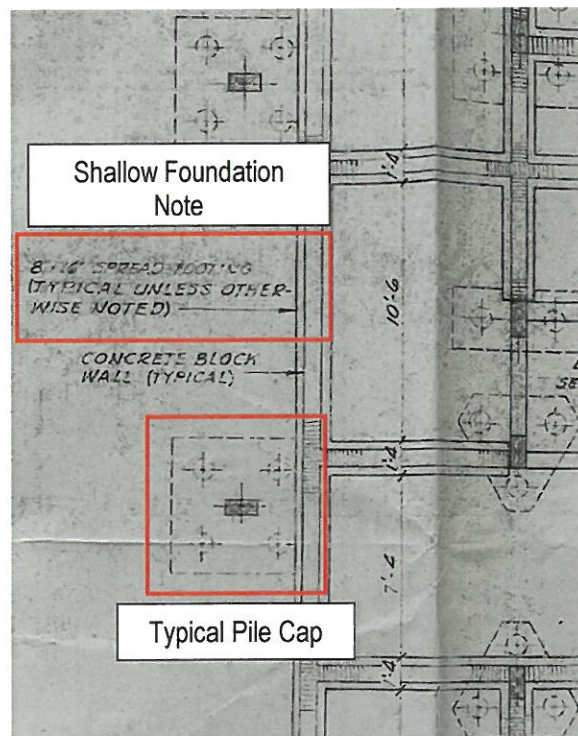
Section of Foundation Plan for the Structure

Based on the limited plans provided by the association, KEG understands that the primary building foundation consists of piles with the first floor appearing to be ground supported shallow foundations. KEG did not perform any investigative excavation at the footings to identify the type of foundation for the structure. Shallow foundation describes footings and other types of foundations that do not extend into lower strata of soils. Deep foundations, which are commonly called pile foundations, and can consist of several different types of piles, the most common of which are driven or auger-cast piles and are common for this type of building and site conditions.

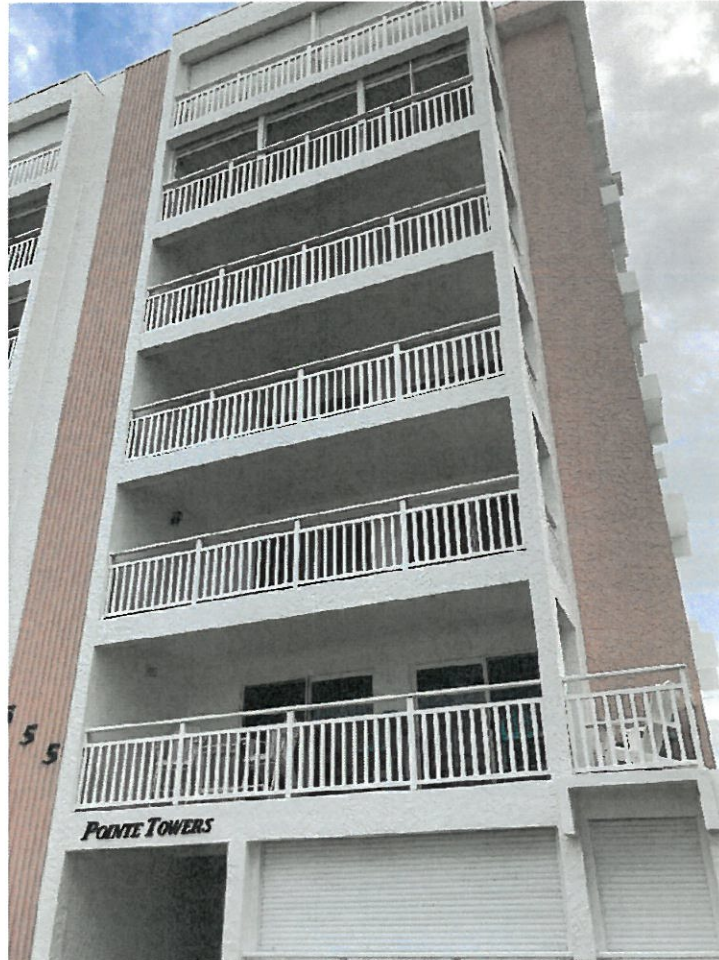
Partial Western Elevation from Adjacent Grade

KEG did not observe any of these behaviors in the structure from the accessible areas. All of the primary structural members appeared to be in generally good condition from the accessible areas.

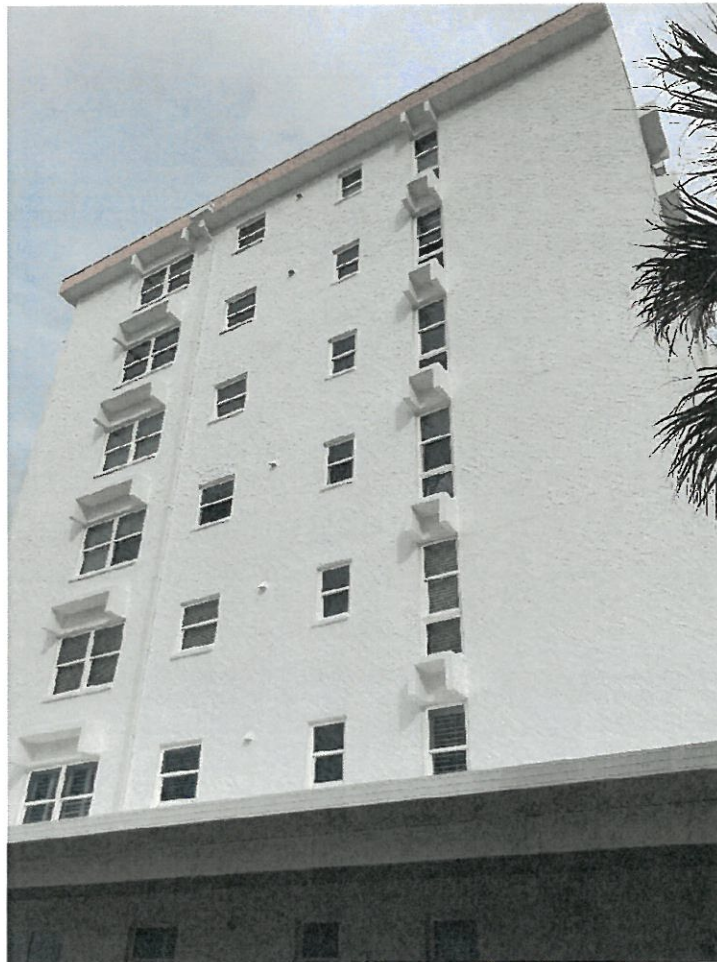
Building West Elevation from Adjacent Grade

KEG did not observe any scattered spalls and minor cracking as would be typical of a building with this type of construction at the time of the milestone inspections. This was due to the recent completion of a building envelope project where the debonding stucco and spalling concrete was identified and addressed. The repaired spalls had been spread throughout the building, including on balconies, columns and beams, as well as window sills. Most notable was that several spalls on the balconies had developed where the ICCP systems had been installed. KEG recommends regular inspections of both the ICCP system and the sections of concrete structure protected by the systems. This will help prevent significant damage from developing as a result of spalling and provide additional information on the performance of the Cathodic protection system.

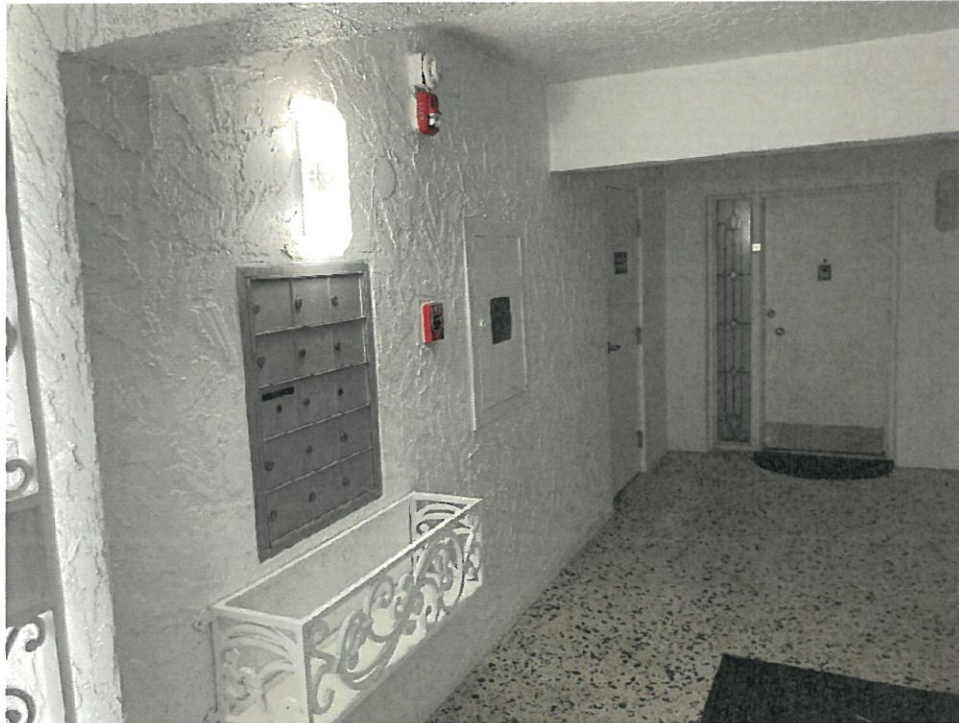
1<sup>st</sup> Floor Breezeway Bearing Walls and Beams

As noted above, the structural systems, including the cement masonry unit walls, concrete columns and beams appeared to be in generally good condition. Also noted previously in the report, there were repaired spalls throughout the building but KEG did not observe any additional cracking or spalling. During the inspections, KEG did not observe any significant cracking or spalling in the lintel beams or sills for the windows and doors on the property.

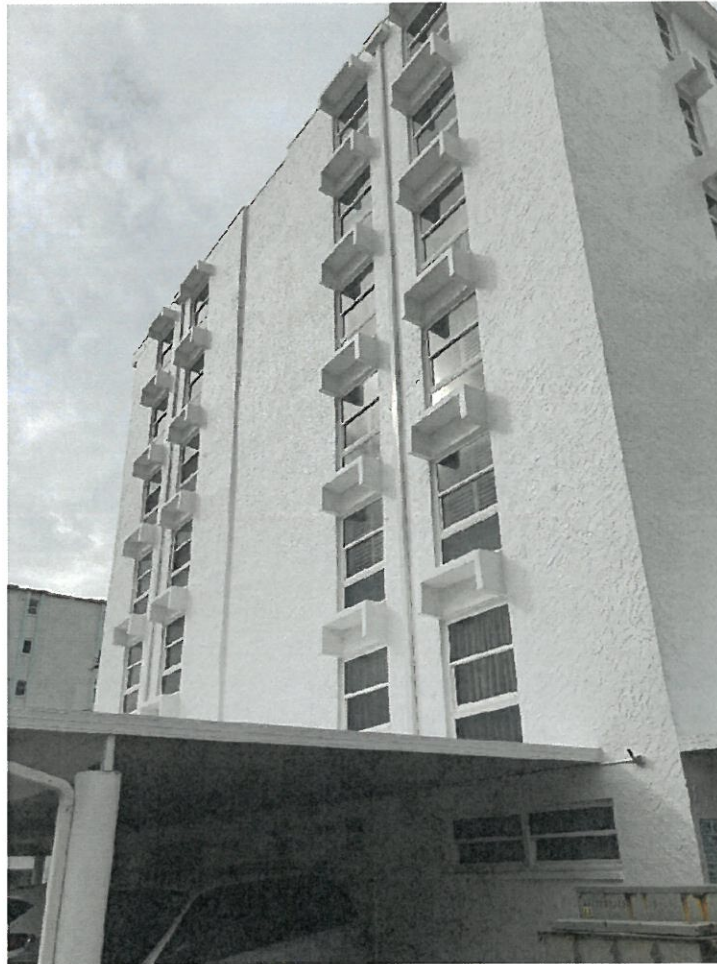
Newly Painted East Face of the Building

These systems are finished with a stucco and paint coating that form the primary moisture barrier and shedding mechanism. These systems appeared to be in excellent condition, as the building had been recently repainted and resealed. This also included an application of a coating system to the balcony decks. Regular installation of a new paint coating is necessary in order to maintain the performance of the system, especially given the level of exposure to sun and salt laden, moist air of Florida.

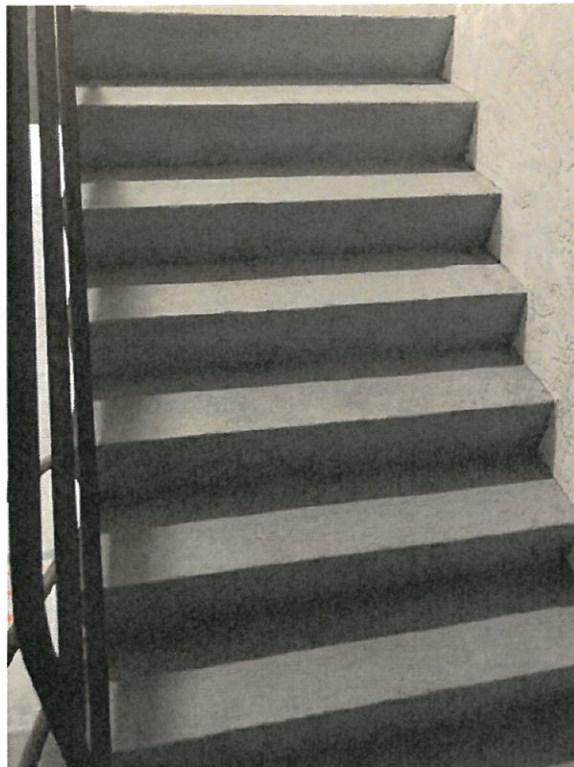
Stair Sections

The stairwells for the building appear to be constructed of conventionally reinforced concrete sections, most likely precast sections. Visual inspections of the stair systems did not indicate any signs of cracking or damage that would indicate deterioration of the element. However, KEG did observe that the coatings for the tread surfaces appeared to be worn and at or near the end of their expected life span. In the case of exposed systems, the coatings perform an important protective role by limiting the intrusion of moisture and chlorides into the concrete, but with interior sections, the primary concern is appearance and anti-slip functions.

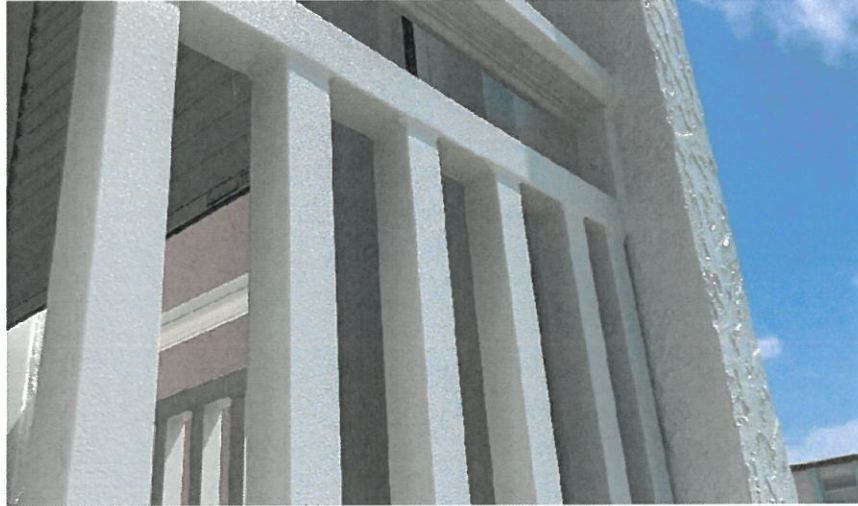
Newly Painted Railing System (Taken 2023-03-27)

The stairs and balconies had guardrails as fall protection for the residents. The balcony railings appeared to be constructed of aluminum and had recently been repainted as part of the building envelope project. The fasteners had also been replaced as part of the project. KEG did not observe any damage to the railings or to the post pockets that would affect the performance of the railings.

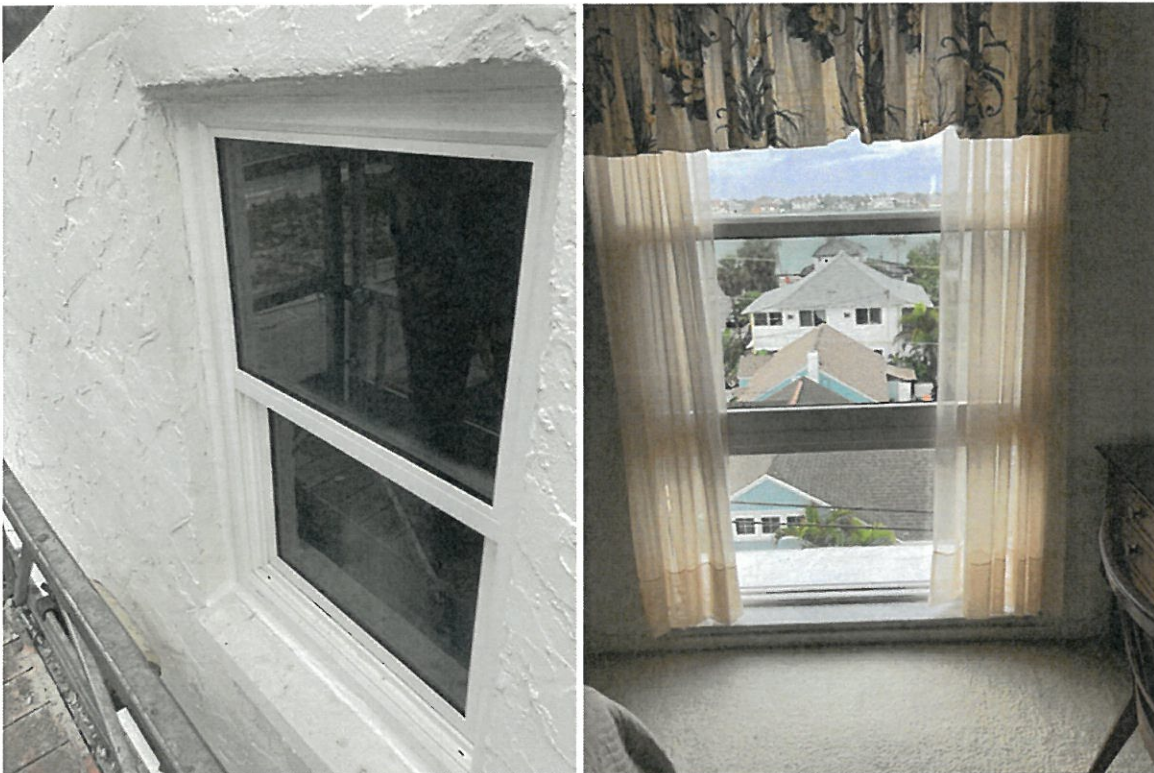
Window Exterior (Taken 2022-12-20) and Window Interior (Taken 2024-01-16)

KEG's visual inspections included documentation of the glazing (windows, sliding glass doors) and doors of the structure. The windows appeared to be in good condition. The windows appeared to have the same construction and apparent condition. The client noted that all of the windows had been replaced at the same time.

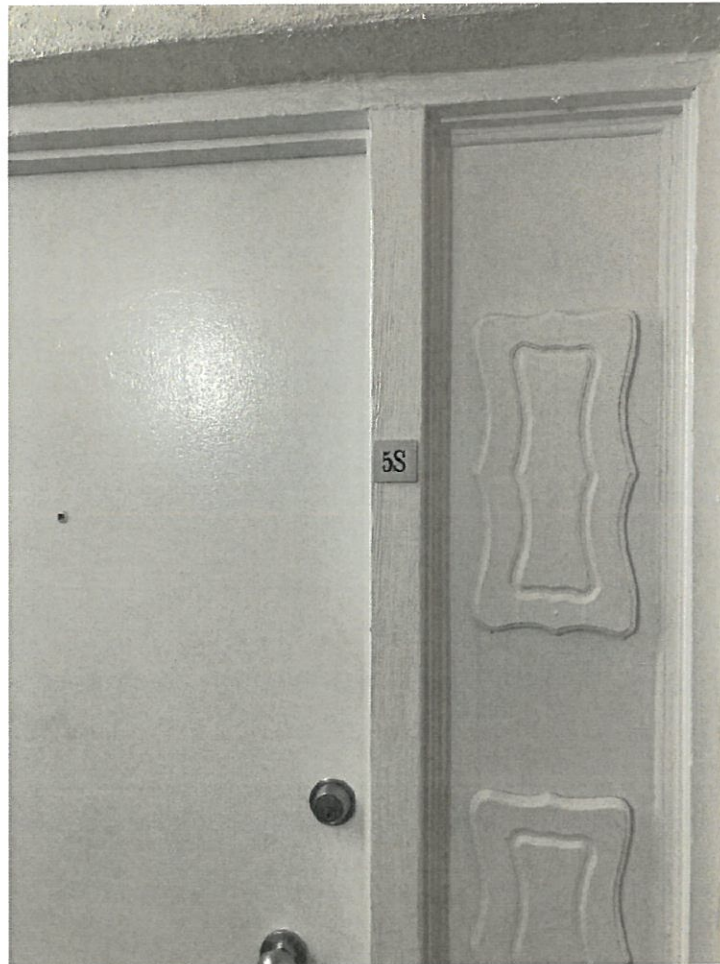
Exterior of Unit Door

Access to the unit was through an interior door that could be used from the elevator landing. Each of the units had two two-panel sliding glass doors that provided access to the balconies. The unit entrance and stairwell doors appeared to be constructed of wood with wood framing. However, the ground floor doors for the utility, elevator room, storage rooms and stairwells were composed of steel with steel framing. These doors had been replaced as part of the building envelope project. The stairwell and unit doors appeared to be in good condition.

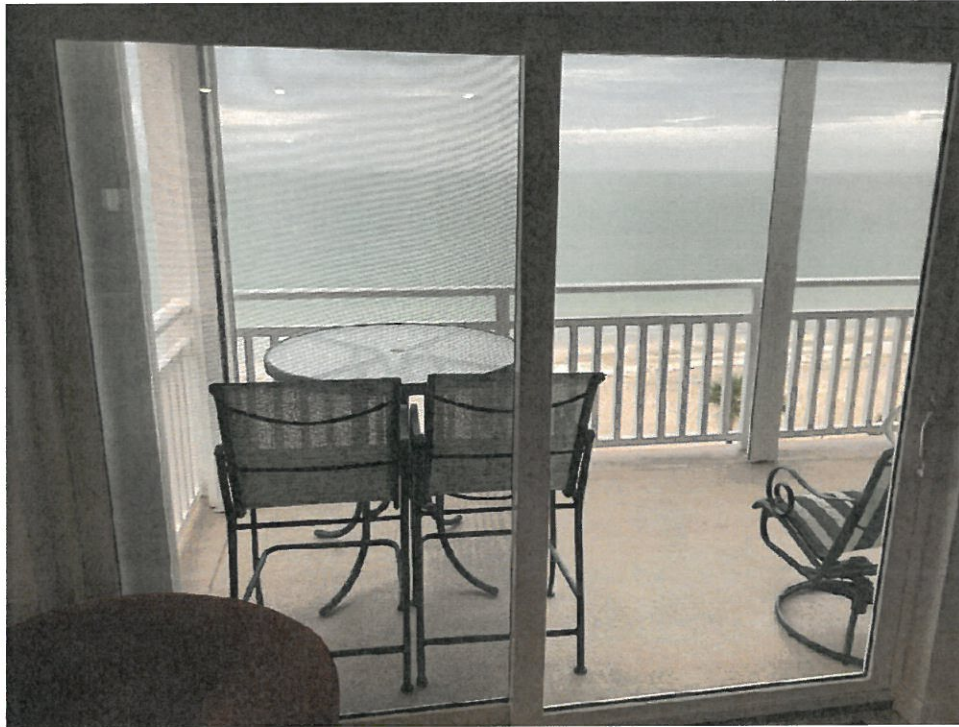
Interior of Unit Sliding Glass Doors

KEG observed that the installed sliding glass doors were vinyl framed. The doors appeared to be in excellent condition. KEG recommends the doors be regularly cleaned and maintained in order to extend the life expectancy of the doors. The sealants for the sliding glass doors and windows were in excellent condition, as they had recently been replaced. These sealants are expected to have a lifespan of 15 to 20 years and should be replaced when they are showing signs of cracking and loss of elasticity in order to continue to properly protect the building.

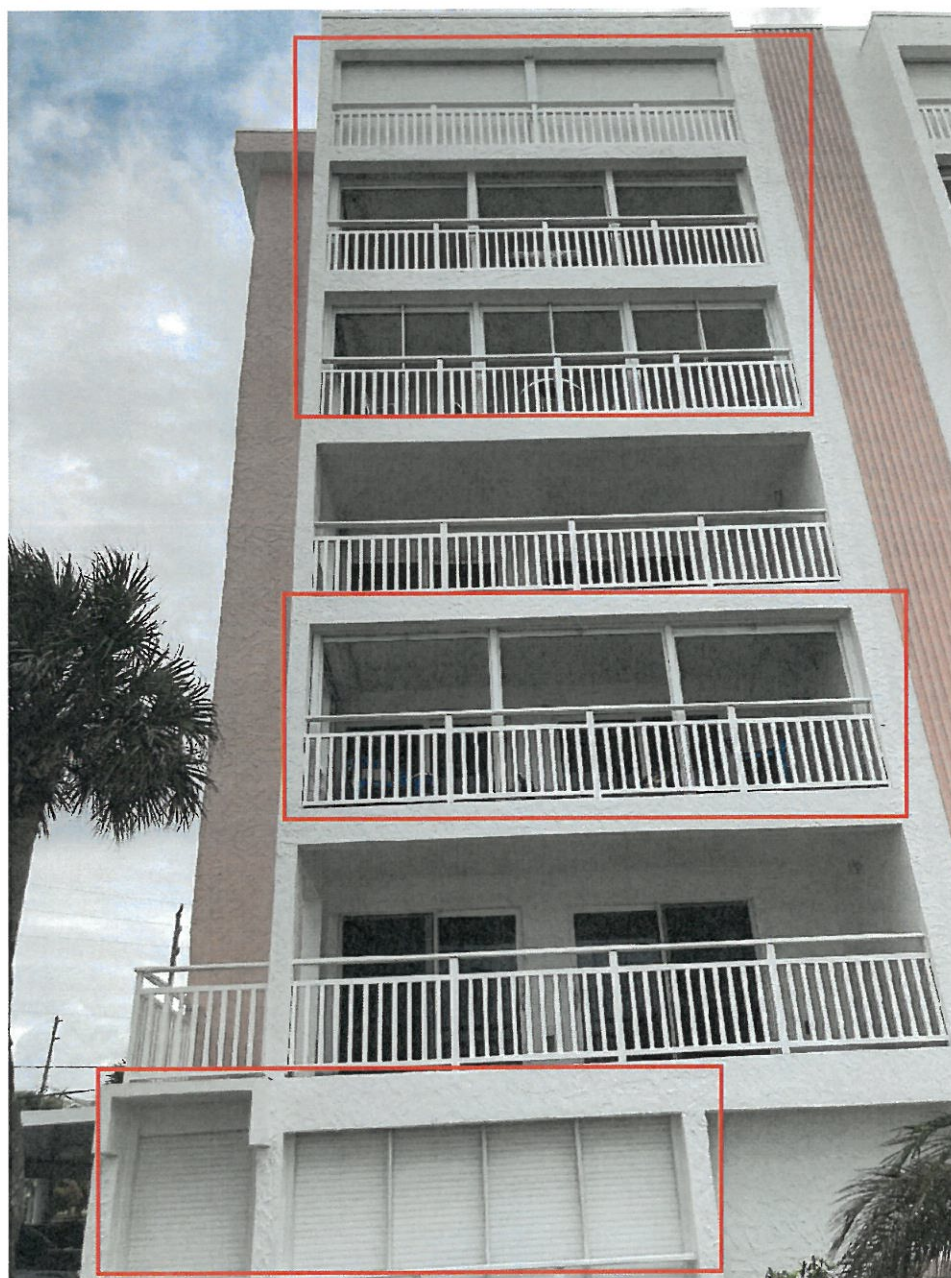
North Stack of Units with Storm Shutters Identified

A number of the balconies had been equipped with storm shutters, which provided protection during significant storm events, but can also be a very effective tool for protecting the sliding glass door systems when they remain closed for long stretches of the year, such as the case when part time residents own a unit.

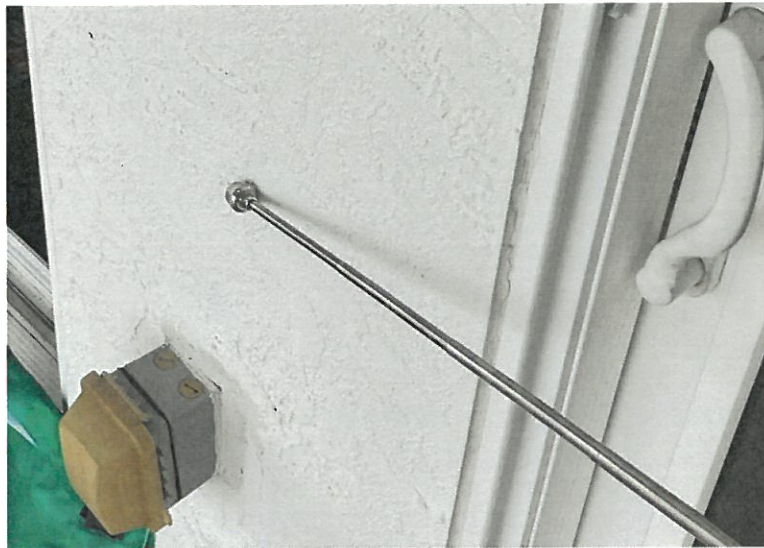
Mechanical Sounding of Balcony Finishes

While on site, KEG documented the current state of the exterior finishes and coatings using visual inspection. Field testing was limited to sounding of the surface to identify concerns with the coatings and finishes. Sounding tests the material for loose or cracked sections by running a metal tool over the surface while the tester listens for any changes to the tone or quality of the sound. Hollow sounds can indicate debonding or material loss from the main element, while “crackling” or “crinkling” sounds can indicate cracks in the surface or loss of adhesion for the paint coatings.

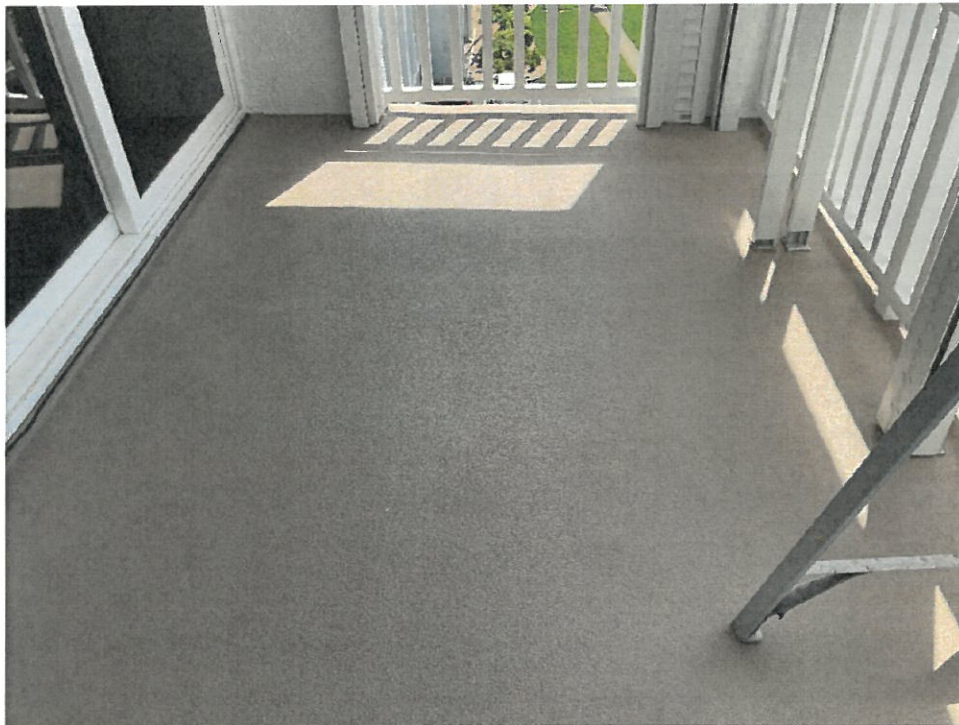
Applied Floor Coating on Balcony

The balconies had recently been refinished with the MasterBuilders HB400 system over the existing coating system, which was StoCoat Acryl and the ICCP cathodic coating. The HB400 system consisted of two coats of HB400 and one coat of MasterKure CC 1315. A waterproofing system was not used due to the limitations and requirements of the cathodic coating, which required a breathable system. These systems have three purposes, visual appeal, installation of a non-slip or limited slip surface, and as a barrier against moisture and chloride intrusion. The coatings appeared to be in excellent condition with only minor build-up of deposits due to some ponding on one of the balconies. As noted in the structural section of this report. KEG observed several sections of spalled or debonded material which were repaired during the building envelope project. The current lifespan of the coatings will be heavily dependent on the condition of the ICCP anodic coating.
